The Shade Tree Mechanic

By Mike Johnston
VMCCA Technical Vice President

Oil Consumption

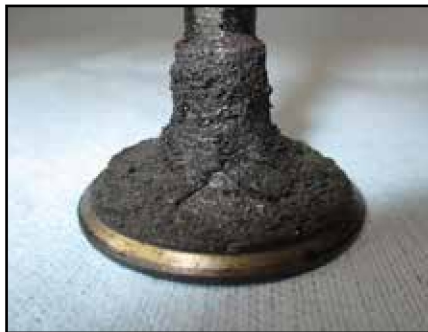
Extreme oil coking on the back side of an intake valve. This is caused by oil being pulled past the valve guide and baking to the valve.

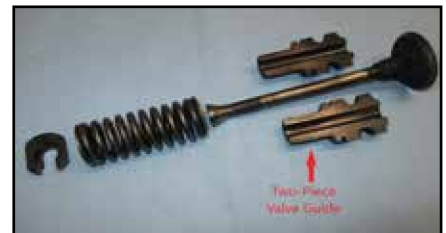
Flathead two-piece valve guide design. Oil can be pulled through the split line between the guide halves, around the O.D. of the guide and between the valve stem and guide.

Older engines may also experience oil pulling past the intake valve guide due to design, for example the Ford flathead engines. The guides in these engines are a slip fit into a bore in the block and before about 1949 were a two-piece, split design with no outside

diameter (O.D.) seal. This design provided the oil with three paths to enter the engine, through the small clearance around the O.D. of the guide, through the split line between the guide halves and past the valve stem through the small clearance to the guide.

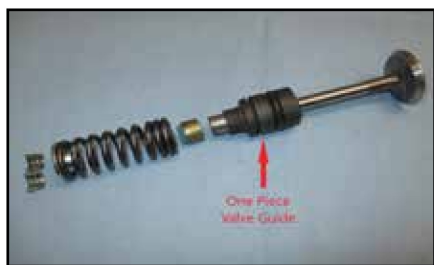
One-piece valve guide design introduced in about 1949.

Starting in about 1949 the guides became a solid design eliminating the split line and an O-ring seal was added to the O.D. of the guide to better seal the guide to the block. This new design helped to reduce or eliminate two of the three paths of oil entry found in the

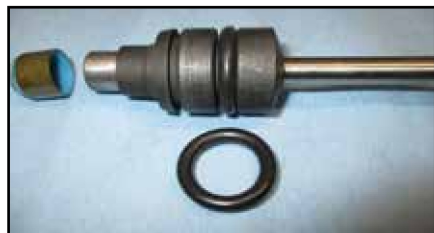
The large O-ring shown was also added to the one-piece guide to prevent oil from being pulled around the O.D. of the guide. A valve stem seal is shown to the left.

The final oil entry path has been reduced or eliminated in most newer engines through the addition of a valve stem oil seal. This seal acts like an umbrella to effectively seal the valve stem to the guide and stop oil from passing between the valve stem and the guide. Valve stem seals of this type were never added to the Ford flathead in production but I did come across one shop that is offering these for a flathead.

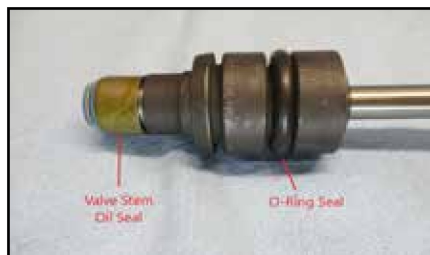
One-piece guide shown with the valve stem seal installed to the left and the O-ring seal installed around the guide O.D.

In order to use this valve stem seal, the O.D. of the smaller end of the valve guide must be reduced in diameter.

The seal then pushes over the guide and the valve stem passes through the seal. This final piece of updated technology should help to bring this old-tech engine closer to the modern age, at least from an oil consumption perspective. We'll see you down the hopefully slightly less smoky road. 🚗

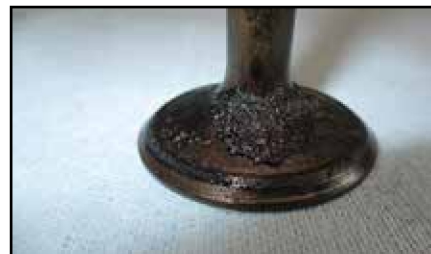
I had been running a one-piece valve guide and when the engine was recently disassembled, I was surprised to find some oil coking on the backside of the intake valves. Based on monitoring the dipstick this engine did not consume oil in its normal 2,000-mile oil change period but the coking showed that it used a small amount.

A small amount of oil coking on the backside of an intake valve.
